实验室安全检查通报

东北林业大学 实验室管理与条件保障处

检查内容：实验室安全检查

检查范围：生命学院科研实验室

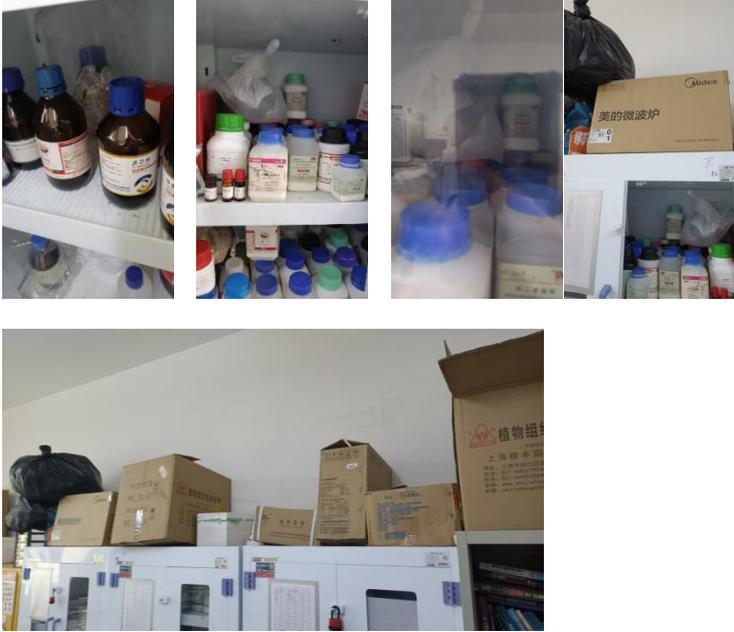
| 检查日期 | 实验室 房间号 | 检查问题记录 |
|---|---|--|
| 2025年3月12日 | 逸夫教学楼201 | 1、正己烷未低温保存； 2、试剂柜内化学品未规范存储，化学试剂叠放； 3、实验室内堆放大量易燃品（如纸箱）存在消防安全隐患。 |

| 实验室名称 | 隐患图 |
|---|---|
| 201 | <p>The images for laboratory 201 show several safety hazards. The top row contains four photos: 1) A shelf with several bottles, some with labels, and a plastic bag. 2) A shelf with many small bottles and containers, some in plastic bags. 3) A shelf with large blue-capped bottles. 4) A microwave oven (美的微波炉) on a shelf with boxes and other items. The bottom row shows a larger view of a cabinet area with several cardboard boxes stacked on top, one labeled '植物组织' (Plant Tissue).</p> |

请学院督促以上实验室立即进行整改，并撰写整改报告（整改报告模板见实验室管理与条件保障处网站<https://elab.nefu.edu.cn/info/1052/1633.htm>），于**3月28日**前提交实验室管理与条件保障处备案，其他实验室举一反三，排查问题，杜绝隐患。

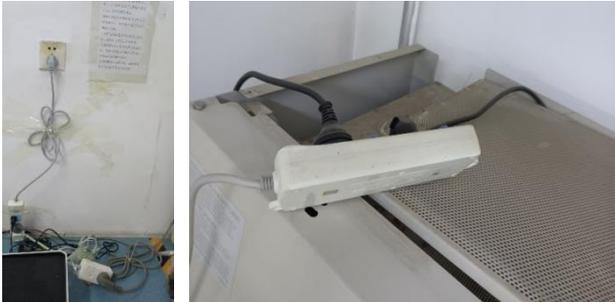
| 检查日期 | 实验室 房间号 | 检查问题记录 |
|---|---|--|
| 2025年3月12日 | 逸夫教学楼306 | 1、接线板串联； 2、接线板未进行有效固定。 |

| 实验室名称 | 隐患图 |
|---|---|
| 306 | <p>The images for laboratory 306 show electrical safety hazards. The left photo shows a power strip plugged into a wall outlet with multiple cables plugged into it. The right photo shows a power strip plugged into a benchtop outlet, with several cables plugged into it.</p> |

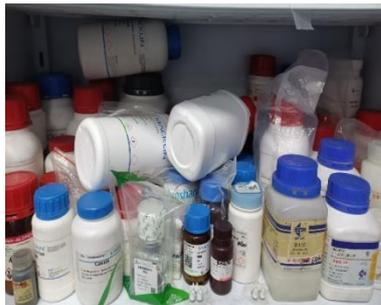
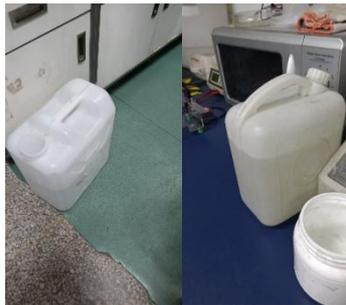
332

| 检查日期 | 实验室 房间号 | 检查问题记录 |
|---|---|--|
| 2025年3月12日 | 逸夫教学楼332 | 1、试剂柜内化学品未规范存储，化学试剂叠放； 2、实验室化学品超量存放（单一包装容器不应大于20L或20kg）； 3、自配试剂未张贴完整清晰的试剂标签。 |

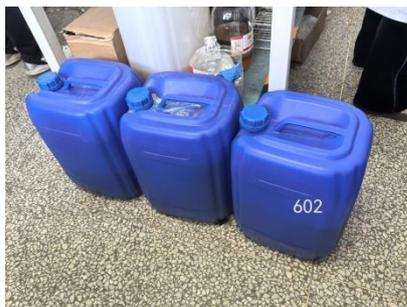
602

| 检查日期 | 实验室 房间号 | 检查问题记录 |
|---|---|--|
| 2025年3月12日 | 逸夫教学楼602 | 1、废液桶无标签，没有标明废液成分，无防渗漏托盘及废液回收区安全警示标识。 |

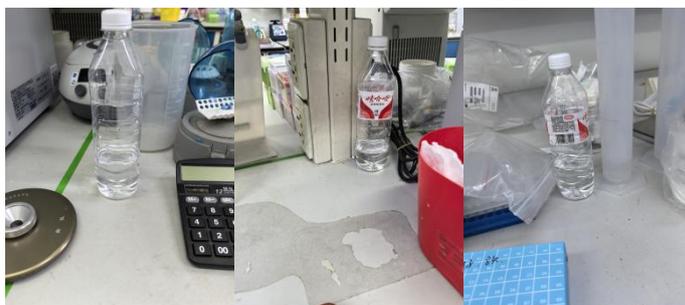
605

| 2025年3月12日 | 逸夫教学楼605 | 1、实验台面摆放多瓶娃哈哈水瓶，未张贴成分标签。 |

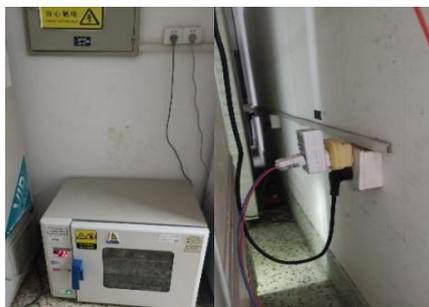
3楼走廊

| 2025年3月12日 | 逸夫教学楼3楼 走廊 | 1、加热设备置于走廊，影响防火通道的畅通； 2、加热设备遮挡配电箱； 3、电源虚接，轻触出现电火花，存在用电隐患； 4、走廊存放摇床等多台设备，且多台设备共用一个接线板，存在用电过载隐患。 |

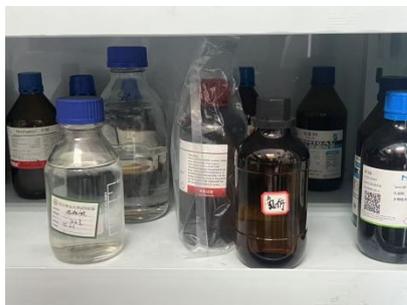
313

| 2025年3月19日 | 逸夫教学楼313 | 1、管制类化学品存储不规范，未按配伍禁忌存储，易制爆药品(高氯酸)与酒精等化学试剂混放；易制毒药品(三氯甲烷)未专柜存储、无药品标签、无登记台账； |

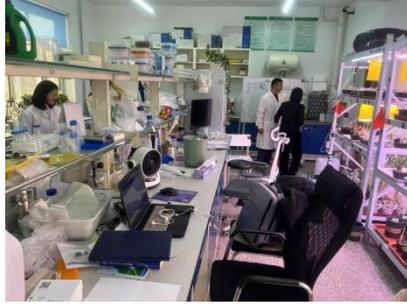
228

| 2025年3月19日 | 逸夫教学楼228 | 1、实验室布局不合理，学习区与实验区没有明确区分。 |
