实验室安全检查通报

东北林业大学 实验室管理与条件保障处

检查内容：实验室安全检查

检查范围：理学院教学科研实验室

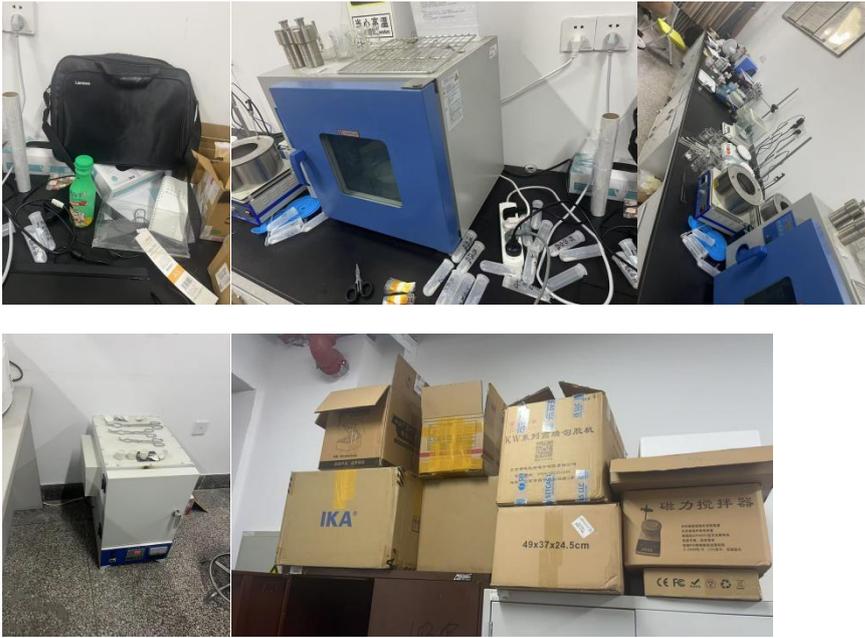
实验室名称	隐患图
103

检查日期	实验室房间号	检查问题记录
2025年7月3日	103	<ol style="list-style-type: none">实验室有饮食行为，实验台上有饮料瓶；未按管理要求，私自使用插排连接多台加热设备供电，（烘箱、电阻炉功率大、电流大，如使用接线板供电，易造成接线板过载，导致火灾事故），存在消防安全隐患。实验室存放大量纸箱易燃物品，遇到明火、高温或电火花等火源极易燃烧，可能引发火灾；实验室卫生环境差；实验室风险评估不全面，请实验室全面排查各类危险源，动态调整实验室风险等级，完善防控措施。

<p>The image contains four photographs illustrating safety hazards in a laboratory. The top-left photo shows a cluttered workbench with a black bag, a green bottle, and various papers. The top-right photo shows a blue piece of equipment with tangled cables and scattered pipette tips. The bottom-left photo shows a white cabinet with tools and papers on top. The bottom-right photo shows a stack of cardboard boxes, including one labeled 'IKA' and another '磁力搅拌器' (magnetic stirrer).</p>

请学院督促实验室立即进行整改，并撰写整改报告（整改报告模板见实验室管理与条件保障处网站<https://elab.nefu.edu.cn/info/1052/1633.htm>），于7月9日前提交实验室管理与条件保障处备案，其他实验室举一反三，排查问题，杜绝隐患。
